Soon after deployment, the system detected a rapid bearing and coupling failure in a boiler draft fan.

Customer Case Study

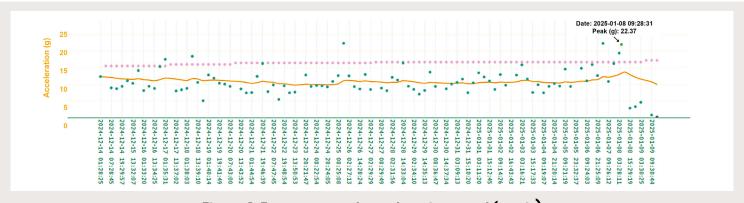
Figure 1: Fan sensor peak acceleration trend (z-axis)

A rapid increase was observed in the peak acceleration trends of the fan, which exceeded the **Loctite Pulse** automated threshold criteria (Figure 1). A notification was immediately generated and sent to maintenance personnel on-site.

The following day, a sudden increase in harmonic content was observed, triggering an automated fault-specific amplitude notification.

Further investigations and a root cause analysis performed by maintenance staff found that the fan bearings had become stuck on the shaft, with the entire bearing rotating in the housing. This also led to a coupling fatigue failure, as the axial thrust of the fan was no longer mitigated by the bearing. Damage also occurred to the gearbox, where looseness developed.

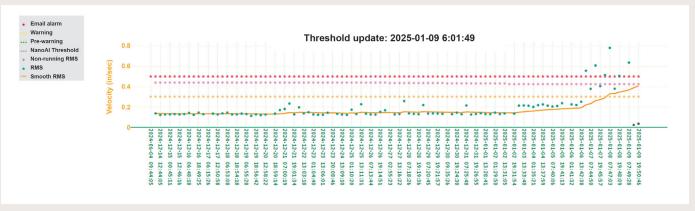
Figure 2: Gearbox sensor, output shaft, RMS velocity trend (x-axis)

4 Significant increases in RMS velocity and peak acceleration were also detected in the gearbox data (Figure 2). Notifications were sent out as these levels exceeded both automated thresholds and user-set custom thresholds.

Additionally, a sudden increase in harmonic content triggered fault-specific amplitude notifications for the gearbox, indicating an output shaft misalignment.
