BALL MILL PREVENTATIVE MAINTENANCE IMPROVED WITH LOCTITE® NORDBAK HIGH IMPACT WEARING COMPOUND

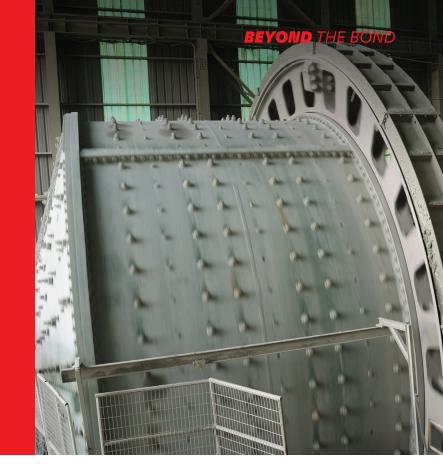
A mine wanted to upgrade preventative maintenance procedures for the trunnion and trommel components of the ball mill equipment. Previous maintenance repairs were costly and had long cure times. These critical pieces of equipment process 50,000 tons daily- so the mine wanted a quick and efficient solution.

Plant maintenance engineers consulted with their local LOCTITE[®] Technical Sales Engineer. They reviewed the demanding operational requirements and recommended LOCTITE[®] PC 9313[™] Nordbak High Impact Wearing Compound. The non-sag formula readily conforms to overhead and irregular surfaces. It is a fast curing two-component rubber modified epoxy which is engineered to deliver better sliding wear and impact resistance than ceramic tile.

After extensive evaluation Plant Maintenance Engineers incorporated LOCTITE[®] PC 9313[™] Nordbak High Impact Wearing Compound into the Ball Mill preventative maintenance procedure. The trunnions and trommels are checked monthly. After three months of punishing service the wear coating is refurbished. A valuable and time-saving feature of this product is that new applied wear coating adheres well to previously applied wear coating. This preventative maintenance procedure delivered documented cost savings and maintained the through-put of this valuable plant equipment.
