# PAPER MILL COMPANY EXCEEDS ROI THANKS TO LOCTITE®

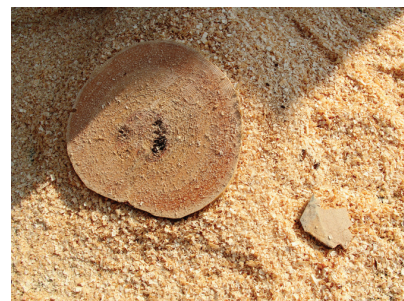
A Paper Mill company was having trouble with saw dust wearing away the steel chute resulting in a leaking chute. The leaking saw dust creates a fire hazard, slip hazard and labor to solve the issues. These frequent leaks are currently being fixed by shutting down the line and replacing the chute. They decided to work with LOCTITE® to evaluate alternative solutions to extend the uptime of their equipment and reduce failures.

The LOCTITE® expert reviewed the requirements and recommended LOCTITE® PC 7317™, a polymer composite protective coating. LOCTITE® PC 7317™ protects against abrasion, erosion, and corrosion providing a lasting protection. The steel chute was cleaned, sandblasted, and the LOCTITE® PC 7317™ was applied to rebuild the worn areas to like new and protect against future wear.
