Waste Treatment Plant Reduces Waste by 90% with LOCTITE® Solutions

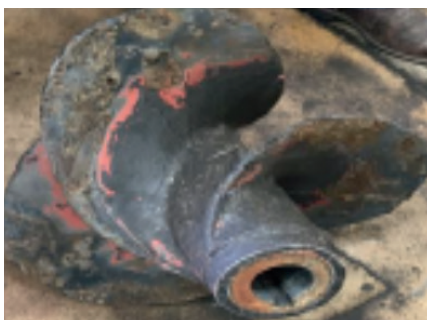
A wastewater company experienced harsh wear of their solids and liquids mixer impellers. Impellers were run until extensively worn out and then replaced. Purchasing new impellers became costly, which left the company searching for a new solution. They decided to work with LOCTITE® to evaluate alternatives.

The steel impeller was sandblasted clean. Worn areas were rebuilt with LOCTITE® EA 3478™ Superior Metal epoxy. Then one coat of blue and a second of grey brushable ceramic protective wear coating were applied – LOCTITE® PC 7227BL™ and LOCTITE® PC 7227GY™. This two color coating provides a preventive maintenance wear indicator. The impeller can be scheduled for maintenance when the blue layer of wear coating becomes visible. In this trial the protective wear coating had minimal wear even after 18 months.
