PRODUCTION LINE SAVED THANKS TO LOCTITE®'S STRENGTH

LOCTITE® 609™ RETAINING COMPOUND

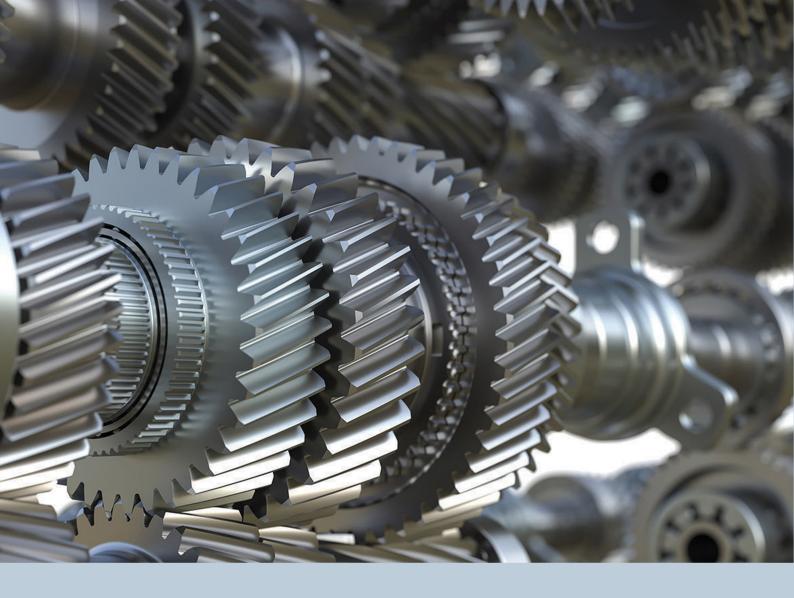
An electro-coating company was facing a lot of down time required to remove and repair large gear boxes that drove a production line. The weight of the large gear box required a lift and several man hours to remove and reinstall. This was losing the company time and money each time the gear box went down. They needed a solution that had strength to retain the main gear coupling and could be easily repaired on the line.

The LOCTITE® expert came into the facility and cleaned and removed any surface contamination on the gear boxes metal components. They then used LOCTITE® 609^{TM} retaining compound around the output shaft just ahead of the gear location as well as in the keyway. LOCTITE® 609^{TM} is designed for the bonding of cylindrical fitting parts by curing in the absence of air and provides greater assembly strength than shrink fitting. It also allowed the coupling to be replaced with the gear box still in place.

After testing, LOCTITE® 609™ proved to have much more strength than the shrink fitting previously used. There were less issues where the gear box needed to stop. If it did need to stop for any reason, it was able to be serviced without the need to be removed – saving the company time and money. LOCTITE® 609™ proved to be the solution that the company needed, as throughput increased and downtime decreased.
