WEAR AND CORROSION IN CENTRIFUGES REDUCED WITH LOCTITE®

LOCTITE® **PC 7332**[™]WEAR RESISTANT COATING
LOCTITE® **SF 7840**[™]BIODEGRADABLE CLEANER
LOCTITE® **SF 7611**[™]PRO STRENGTH PARTS CLEANER

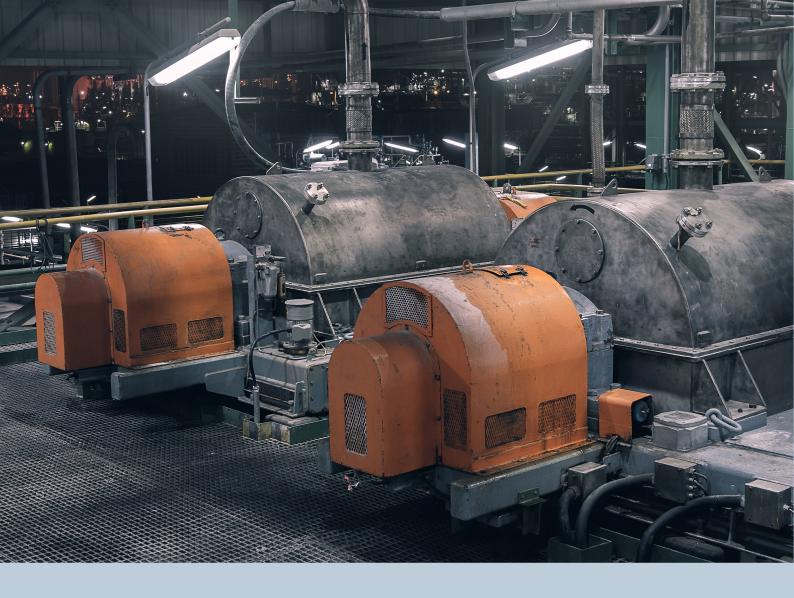
A company was having trouble with abrasion and corrosion inside their industrial centrifuges. Wear was forming in the bowl and lower housing components causing field failures. They were looking for a solution that would prevent wear and restore worn surfaces on new and rebuilt centrifuge bowls and lower housing. They needed these centrifuges to last longer and be protected from external corrosion as well.

The local LOCTITE® expert removed dirt, oil and grease with a high-pressure water cleaning system using LOCTITE® SF 7840™ cleaning solution. They then blasted all surfaces to be coated with a degree of cleanliness of near white metal and used LOCTITE® SF 7611™ after blasting to remove dust and contaminants. Finally, LOCTITE® PC 7332™ wear prevention coating was applied, which is designed to protect, rebuild, and repair high wear areas of equipment. After initial testing, LOCTITE® expert trained the maintenance team on the solution and process to protect the centrifuges from external contaminates and prevent wear and abrasion. The housing is now lasting longer and is protected, which is reducing field failures – saving maintenance time and costs.
