TECHNOMELT.

Roll Fed Labels Roller Applied Hot Melt Troubleshooting Guide

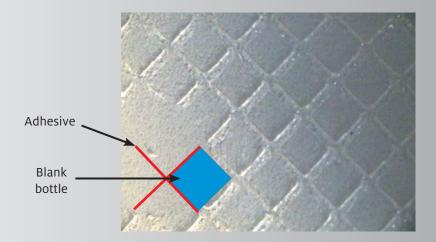
The application should have clearly defined diamonds across the entire pattern to assure consistent adhesion. Application quantity can be adjusted by shifting the vacuum drum closer or further from the adhesive roller – closer to increase adhesive transfer, further to reduce adhesive transfer.

*Alternative patterns can be cut/gravured into the adhesive roller.

Adhesive pattern should reflect roller pattern. Diamond pattern is the most common.
