# WEAR AND CORROSION IN CENTRIFUGES REDUCED WITH LOCTITE®

### LOCTITE<sup>®</sup> PC 7332<sup>™</sup> Nordbak<sup>®</sup> Wear Resistant Coating

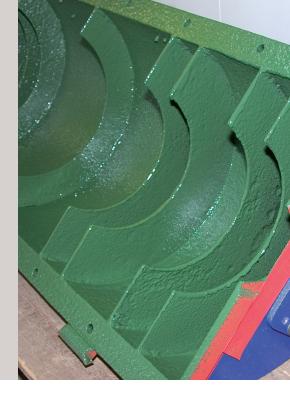
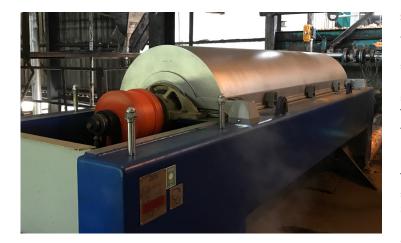
A company was having trouble with abrasion and corrosion inside their industrial centrifuges. Wear was forming in the bowl and lower housing components causing field failures. They were looking for a solution that would prevent wear and restore worn surfaces on new and rebuilt centrifuge bowls and lower housing. They needed these centrifuges to last longer and be protected from external corrosion as well.

The local LOCTITE Expert removed dirt, oil and grease with a high-pressure water cleaning system using LOCTITE<sup>®</sup> SF 7840<sup>™</sup> cleaning solution. They then blasted all surfaces to be coated with a degree of cleanliness of Near White Metal and used LOCTITE<sup>®</sup> SF 7611<sup>™</sup> after blasting to remove dust and containments. Finally, PC 7332<sup>™</sup> wear prevention coating was applied. PC 7332<sup>™</sup> is designed to protect, rebuild, and repair high wear areas of equipment.

After initial testing, LOCTITE trained the maintenance team on the solution and process to protect the centrifuges from external contaminates and prevent wear and abrasion. The housing is now lasting longer and is protected, which is reducing field failures – saving maintenance time and costs.
